**Flood Control Project Maintenance  
Levee Inspections**  
**LMA District Cover Sheet**  
**Spring 2019 Levee Inspection Results**

**Reclamation District No. 1660 Tisdale**

**Levee Inspection Report By Mile - Spring 2019**

Waterway	Bank	Unit Miles	Inspection Start/End	Inspector
Unit No. 01 Sacramento River	Left	2.94	04/03/2019 04/03/2019	Makar Sokol

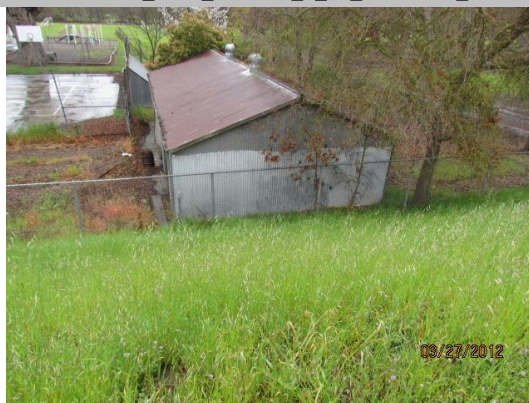
Photo 1 of 1 : SP\_2019\_RD1660\_8\_12\_20190326\_00006.jpg

LM Start	0.05	Rating **	M	Issue No.	12
LM End	0.05	Issue Type +	En	Location *	LS
Category	Earthen Levee			GPS Latitude/Longitude	
				Start	End
Item	Encroachments			39.062643 °	39.062643 °
				-121.837857 °	-121.837857 °
DWR ID	DWR_RD1660_01_s_2012_12				
Comment Code					
BU : Building					
Inspector Comment

View of the building and fence at the landside toe.

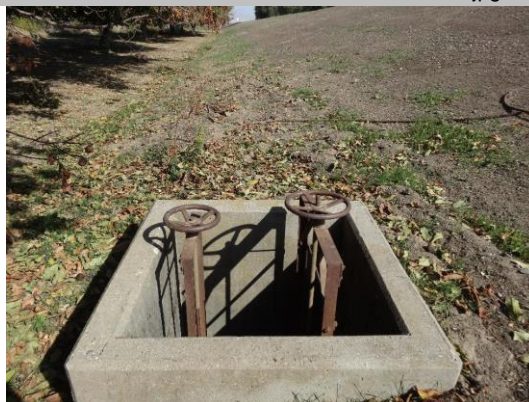
Photo 2 of 3 : UCIP\_SP\_2019\_46670\_38106.jpg

WS view: two slide gates in concrete box on levee slope.

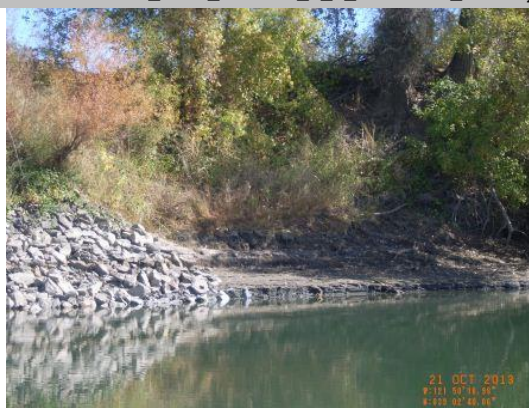
Photo 1 of 1 : SP\_2019\_RD1660\_8\_8\_20190326\_00004.jpg

LM Start	1.33	Rating **	M	Issue No.	8
LM End	1.36	Issue Type +	Ma	Location *	WS
Category	Supplemental			GPS Latitude/Longitude	
				Start	End
Item	2017 USACE Erosion Survey, DRAFT			39.044361 °	39.043916 °
				-121.837654 °	-121.837305 °
DWR ID	DWR_RD1660_01_f_2018_8				
Comment Code					
Inspector Comment					
2017 Site ID: SAC 120.6 L					
Status: Eroding					
2017 Field Notes: No observed change.					
Site History: 2009 - Erosion on levee toe where an old cobble site is failing. 2011 - Some new minor erosion. 2012 - Site extended downstream, bank is being impacted from the weight of the trees.					
2013 - Minor new erosion at the toe. 2015 - Minor new erosion at toe.

USACE 2013 Photo #1

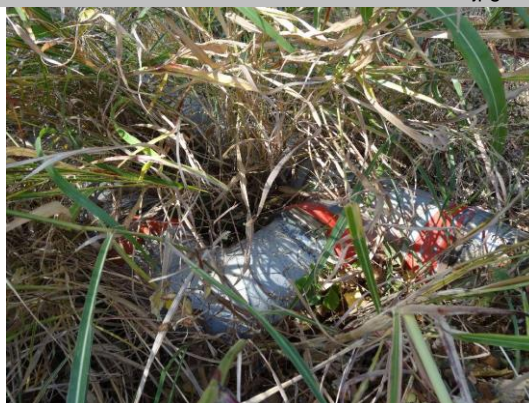
Photo 2 of 3 : UCIP\_SP\_2019\_22543\_38141.jpg

WS view: two exposed 12" tin pipes on levee slope.

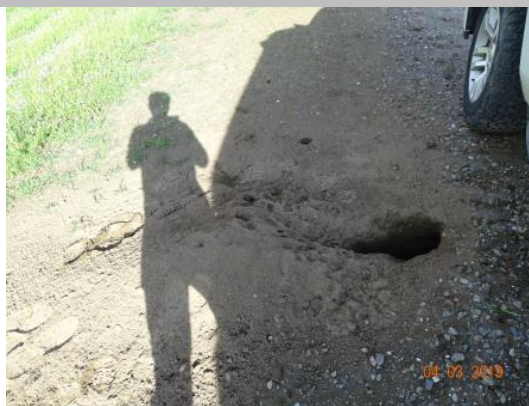
Photo 1 of 1 : SP\_2019\_RD1660\_8\_23\_20190408\_00020.jpg

LM Start	2.36	Rating **	U	Issue No.	23
LM End	2.36	Issue Type +	Ma	Location *	WS
Category	Earthen Levee			GPS Latitude/Longitude	
				Start	End
Item	Animal Control			39.034209 °	39.034209 °
				-121.825316 °	-121.825316 °
DWR ID	DWR_RD1660_01_s_2019_23				
Comment Code					
A3 : No rodents visible, but rodent burrows visible; need to backfill and compact or grout burrows.					
Inspector Comment

View of a large rodent burrow on the waterside shoulder. Spring 2019.

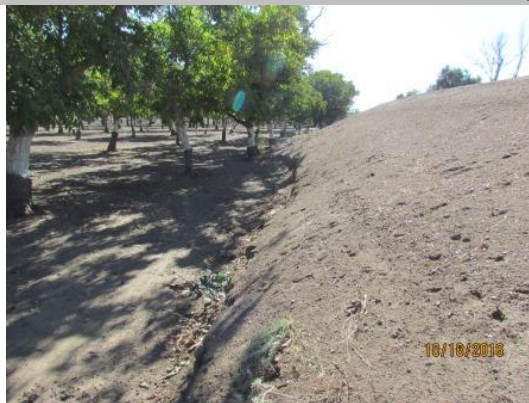
Photo 1 of 1 : SP\_2019\_RD1660\_8\_2\_20190326\_00002.jpg

LM Start	2.37	Rating **	M	Issue No.	2
LM End	2.37	Issue Type +	Ma	Location *	LS
Category	Earthen Levee			GPS Latitude/Longitude	
				Start	End
Item	Slope Stability			39.034107 °	39.034107 °
				-121.825152 °	-121.825152 °
DWR ID	DWR_RD1660_01_s_2012_2				
Comment Code					
S1 : Repair slope instability.					
Inspector Comment

View of the toe cut by the farmer on the landside.

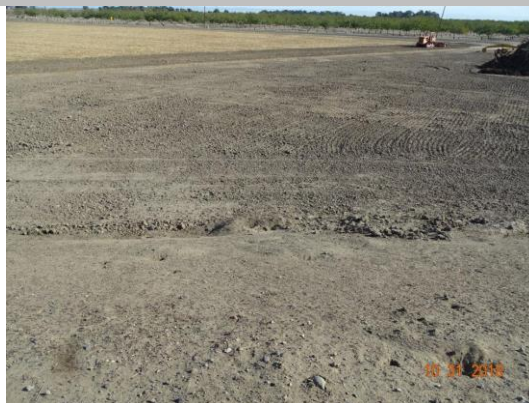
Photo 1 of 1 : SP\_2019\_RD1660\_8\_21\_20190326\_00009.jpg

LM Start	2.38	Rating **	U	Issue No.	21
LM End	2.38	Issue Type +	Ma	Location *	LS
Category	Earthen Levee			GPS Latitude/Longitude	
				Start	End
Item	Animal Control			39.034032 °	39.034032 °
				-121.825120 °	-121.825120 °
DWR ID	DWR_RD1660_01_f_2018_21				
Comment Code					
A3 : No rodents visible, but rodent burrows visible; need to backfill and compact or grout burrows.					
Inspector Comment

View of rodent holes along the landside slope.

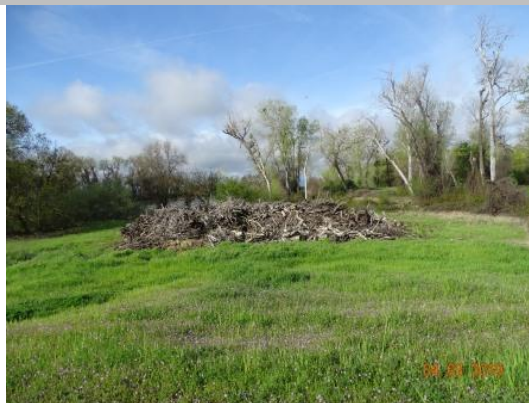
Photo 1 of 1 : SP\_2019\_RD1660\_8\_22\_20190408\_00019.jpg

LM Start	2.45	Rating **	M	Issue No.	22
LM End	2.45	Issue Type +	En	Location *	WS
Category	Earthen Levee			GPS Latitude/Longitude	
				Start	End
Item	Encroachments			39.033183 °	39.033183 °
				-121.824603 °	-121.824603 °
DWR ID	DWR_RD1660_01_s_2019_22				
Comment Code					
PR : Prunings					
Inspector Comment					
Large pile of prunings should be removed from the designated floodway.

View of a large pile of prunings within the designated floodway. Spring 2019.

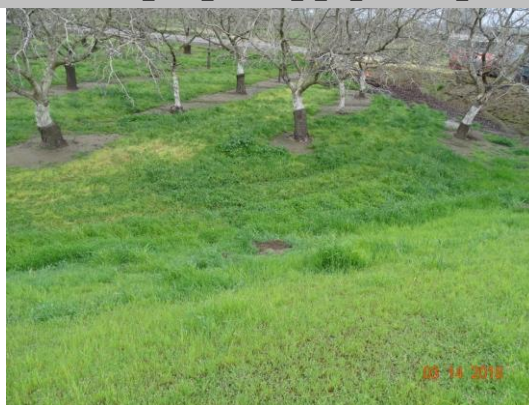
Photo 1 of 1 : SP\_2019\_RD1660\_8\_20\_20190326\_00008.jpg

LM Start	2.57	Rating **	M	Issue No.	20
LM End	2.57	Issue Type +	Ma	Location *	LS
Category	Earthen Levee			GPS Latitude/Longitude	
				Start	End
Item	Animal Control			39.031625 °	39.031625 °
				-121.823492 °	-121.823492 °
DWR ID	DWR_RD1660_01_s_2018_20				
Comment Code					
A3 : No rodents visible, but rodent burrows visible; need to backfill and compact or grout burrows.					
Inspector Comment

View of the rodent holes along the landside slope.

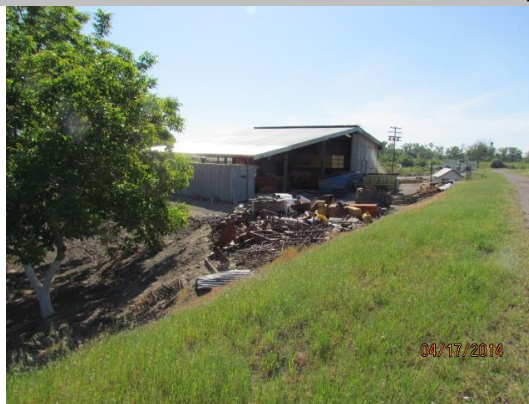
Photo 1 of 1 : SP\_2019\_RD1660\_8\_3\_20190326\_00003.jpg

LM Start	2.58	Rating **	M	Issue No.	3
LM End	2.58	Issue Type +	En	Location *	LS
Category	Earthen Levee			GPS Latitude/Longitude	
				Start	End
Item	Encroachments			39.031405 °	39.031405 °
				-121.823403 °	-121.823403 °
DWR ID	DWR_RD1660_01_s_2012_3				
Comment Code					
EQ : Equipment					
Inspector Comment

View of equipment along the landside slope.

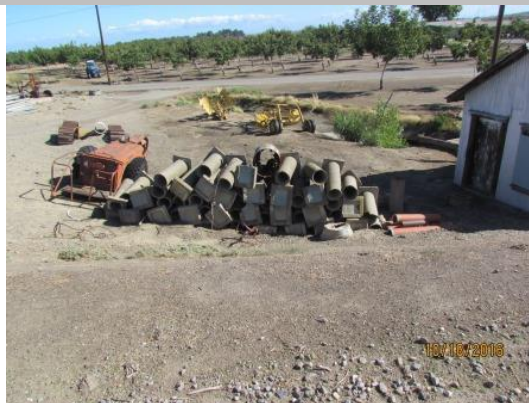
Photo 1 of 1 : SP\_2019\_RD1660\_8\_18\_20190326\_00007.jpg

View of the concrete pipes within the levee easement.

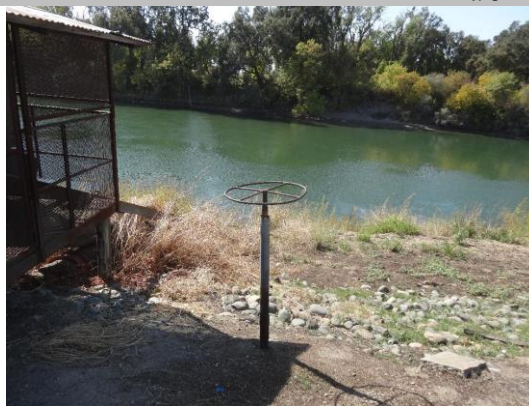
Photo 1 of 3 : UCIP\_SP\_2019\_22632\_38178.jpg

Comment Code						
Inspector Comment						
FS_ID:22632 DS_ID:22492 EP_NO: 10012 Repair Type: Non-Urgent Crossing Status: Found UCIP Comments: - abandoned pumphouse on landside toe. Needs confirmation from LMA or DWR Inspector about abandonment of pumphouse.- headwall on channel bank. FIELD_STRUCT_DESC: 24-inch steel irrigation discharge pipe through the levee, 24 feet below the crown. Slide gate on the waterside (WS) shoulder. Abandoned pump house on the landside (LS) slope. (Retention of a 24-inch steel pipe through the levee, 24 feet below the crown, slide gate, and pump house authorized under Automatic Board Order (ABO) issued as Permit No. 10012, 1974 - Lawrence C. Harris). [Additional Reference(s): DWR Levee Log, 2005]. FS Date: 10/10/2013

WS view: gate valve handle (center) on levee slope.

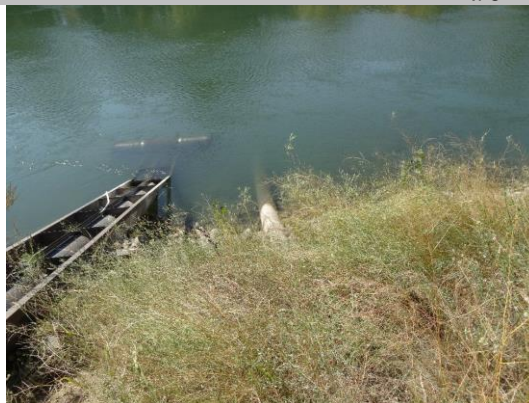
Photo 2 of 3 : UCIP\_SP\_2019\_22632\_38177.jpg

Comment Code						
Inspector Comment						
FS_ID:22632 DS_ID:22492 EP_NO: 10012 Repair Type: Non-Urgent Crossing Status: Found UCIP Comments: - abandoned pumphouse on landside toe. Needs confirmation from LMA or DWR Inspector about abandonment of pumphouse.- headwall on channel bank. FIELD_STRUCT_DESC: 24-inch steel irrigation discharge pipe through the levee, 24 feet below the crown. Slide gate on the waterside (WS) shoulder. Abandoned pump house on the landside (LS) slope. (Retention of a 24-inch steel pipe through the levee, 24 feet below the crown, slide gate, and pump house authorized under Automatic Board Order (ABO) issued as Permit No. 10012, 1974 - Lawrence C. Harris). [Additional Reference(s): DWR Levee Log, 2005]. FS Date: 10/10/2013

WS view: inlet steel pipe (right) immersed into channel water.

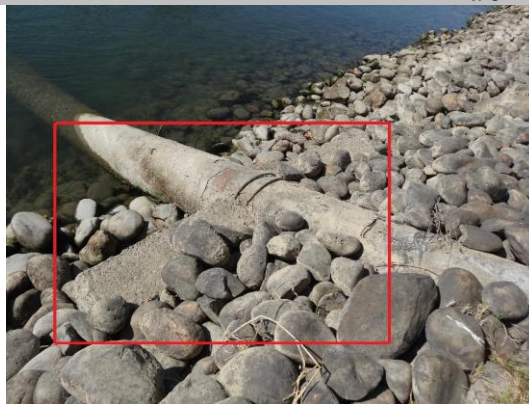
Photo 3 of 3 : UCIP\_SP\_2019\_22632\_38176.jpg

WS view: closer view of inlet steel pipe immersed into channel water.  
Pipe was supported by concrete headwall.

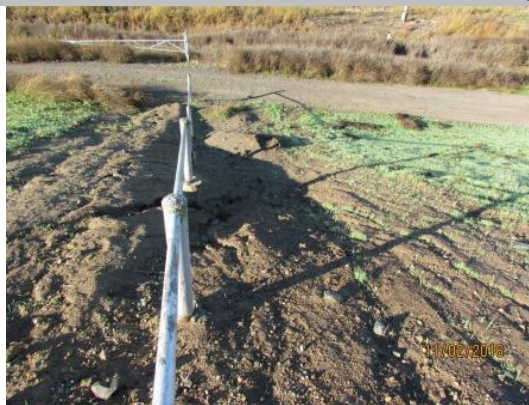
Photo 2 of 2 : SP\_2019\_RD1660\_9\_6\_20190326\_00002.jpg

Another view of the slope instability looking from the levee crown.

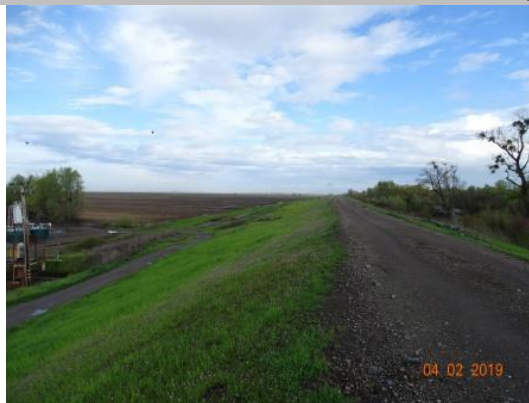
Photo 1 of 1 : SP\_2019\_RD1660\_9\_1\_20190411\_00016.jpg

LM Start	0.00	Rating **	A	Issue No.	1
LM End	2.38	Issue Type +	Ma	Location *	LS
Category	Earthen Levee			GPS Latitude/Longitude	
				Start	End
Item	Vegetation			39.033004 °	39.065780 °
				-121.743451 °	-121.757099 °
DWR ID	DWR_RD1660_02_s_2012_1				
Comment Code					
V1 : Control annual grass and weeds on the levee slopes and easements.					
Inspector Comment					
The vegetation is well maintained on the landside slope.

View of the vegetation on the landside slope. Spring 2019.

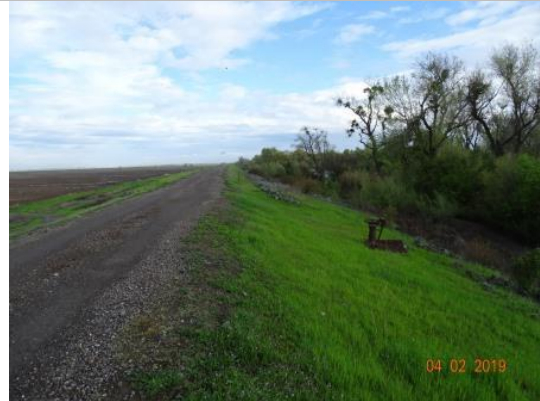
Photo 1 of 1 : SP\_2019\_RD1660\_9\_2\_20190411\_00017.jpg

View of the vegetation on the waterside slope. Spring 2019.

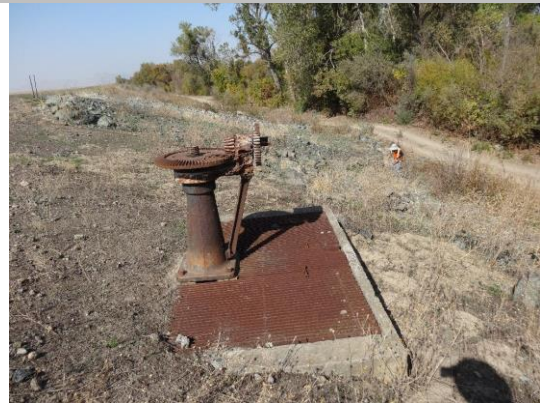
Photo 1 of 3 : UCIP\_SP\_2019\_22663\_38248.jpg

Comment Code						
Inspector Comment						
FS_ID:22663 DS_ID:22495 EP_NO: 10020 Repair Type: No Action Needed Crossing Status: Found UCIP Comments: - pipe/opening not visible as it was submerged into water on both sides.- it seems that 36-inch concrete pipe through the levee. It needs confirmation from LMA/DWR Inspector.- USED bench mark on landside concrete vault. FIELD_STRUCT_DESC: [Reclamation District No. 1660 (RD1660) Drainage Pump] 48-inch by 84-inch reinforced concrete outfall structure through the levee, 34 feet below the crown. Slide gate in a 4-foot by 8-foot concrete riser on the waterside (WS) slope. (Retention of a 4-foot by 7-foot concrete culvert outfall drain through the levee, 34 feet below the crown, and a slide gate in a concrete well authorized under Automatic Board Order (ABO) issued as Permit No. 10020, 1974 - Leo Bandoni, care of John Digardi). [Additional Reference(s): DWR Levee Log, 2005. USACE Sacramento O&M Manual 133, August 1955, (Station 1044+60), two 4-foot by 7-foot concrete tunnels referenced]. FS Date: 10/10/2013

WS view: 4 ft. by 8 ft. concrete box with slide gate on levee slope. USED bench mark on top of the box.

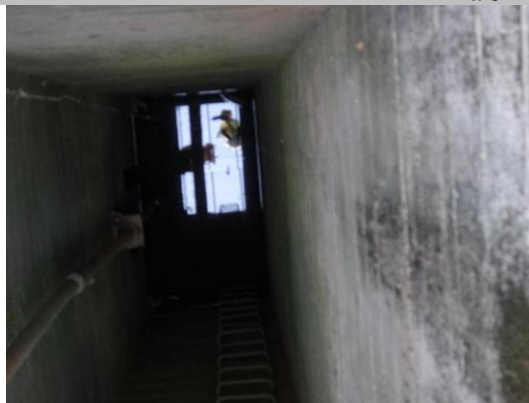
Photo 2 of 3 : UCIP\_SP\_2019\_22663\_38247.jpg

WS view: inside view of concrete box on levee slope. Slide gate in concrete box.

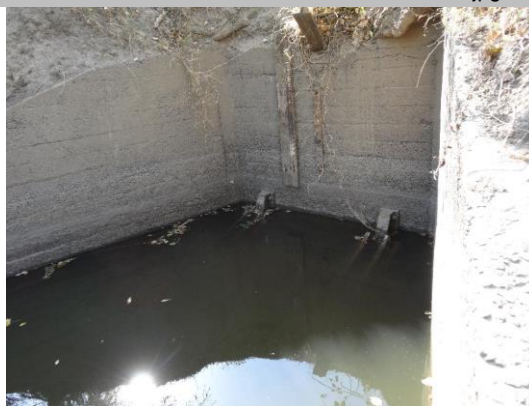
Photo 3 of 3 : UCIP\_SP\_2019\_22663\_38246.jpg

Comment Code						
Inspector Comment						
FS_ID:22663 DS_ID:22495 EP_NO: 10020 Repair Type: No Action Needed Crossing Status: Found UCIP Comments: - pipe/opening not visible as it was submerged into water on both sides.- it seems that 36-inch concrete pipe through the levee. It needs confirmation from LMA/DWR Inspector.- USED bench mark on landside concrete vault. FIELD_STRUCT_DESC: [Reclamation District No. 1660 (RD1660) Drainage Pump] 48-inch by 84-inch reinforced concrete outfall structure through the levee, 34 feet below the crown. Slide gate in a 4-foot by 8-foot concrete riser on the waterside (WS) slope. (Retention of a 4-foot by 7-foot concrete culvert outfall drain through the levee, 34 feet below the crown, and a slide gate in a concrete well authorized under Automatic Board Order (ABO) issued as Permit No. 10020, 1974 - Leo Bandoni, care of John Digardi). [Additional Reference(s): DWR Levee Log, 2005. USACE Sacramento O&M Manual 133, August 1955, (Station 1044+60), two 4-foot by 7-foot concrete tunnels referenced]. FS Date: 10/10/2013

WS view: closer view of U shaped concrete headwall in bypass channel. Pipe not visible.

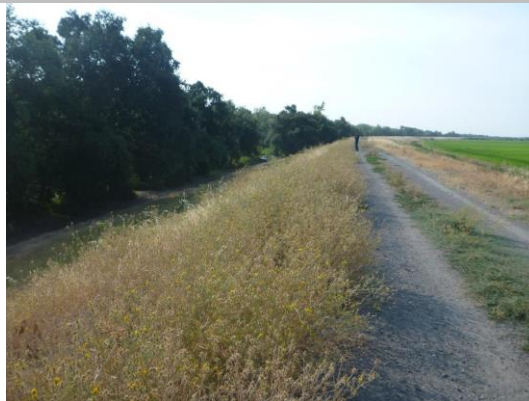
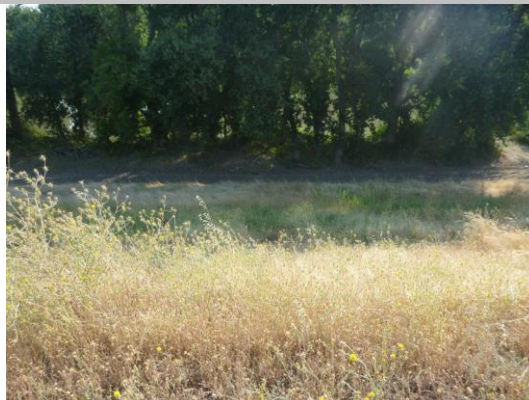
LM Start	5.12	Rating **	A/W	Issue No.	9 (cont)	
LM End	5.12	Issue Type +	Ob	Location *		
Category	Supplemental			GPS Latitude/Longitude		
				Start	End	
Item	2017 Storm Damage			39.102537 °	39.102537 °	
				-121.775390 °	-121.775390 °	
DWR ID	DWR_RD1660_02_f_2017_9					
Comment Code						
Inspector Comment						
Levee Evaluation Comments						
Description:						
Site ID No:157						
Site Designation:RD 1660-01						
Repair Type: Seepage (B)						
Rating:Area of Concern						
Field Date:8/3/2017						
Notes: small bulges, levee prone to seepage

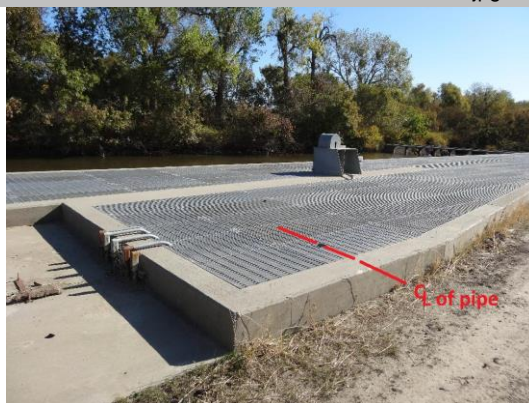
Photo 2 of 3 : UCIP\_SP\_2019\_22708\_38405.jpg

WS view: concrete box on channel bank. Pipe end with slide gate. Pipe discharges into this box.
